ORCHID GLEN SUBDIVISION, EDMONTON

Orchid Glen is a residential estate located in the township of Edmonton, approximately 18km from the Cairns CBD situated in a World Heritage area. The most recent stages under construction comprised of a culvert crossing over Blackfellow Creek and 25 residential lots. The scope of work included:

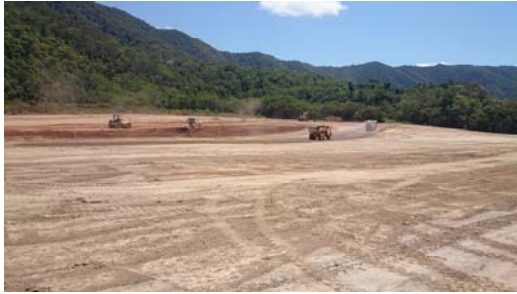
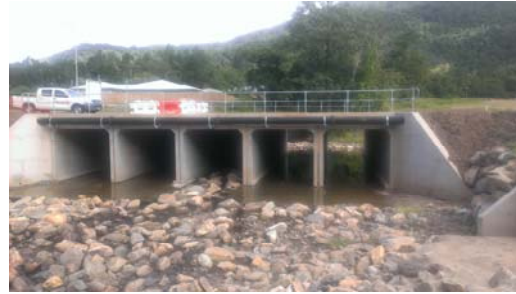
- **3m x 2.7m reinforced Concrete culverts**

These required extensive planning and consultation due to the onset of the wet season and interface with existing services. Sewer, electrical and communications service crossings had to be installed under the base slabs which necessitated a collaborative approach with the design team to accelerate the construction of these. The culverts themselves were constructed following extensive consultation with various environmental stakeholders including the Department of Fisheries and Cairns Regional Council environmental staff. Fgf constructed two separate base slabs with a rock filled central channel which would facilitate fish movement during high flows – an eco-friendly solution in an environmentally sensitive area. Adherence to a tight construction program resulted in minimal weather impacts despite site being subjected to significant flows at times.
